Common Structural Details and Deficiencies in Indonesian RC Buildings: Preliminary Report on Field Investigation in Padang City, West Sumatra

Syafri Wardi^{#†}, Yasushi Sanada[#], Michihiro Kita[#], Jafril Tanjung^{*}, Maidiawati[†]

In this study, a field investigation was conducted to inspect common structural details and deficiencies in newly constructed multi-story RC buildings in Padang. The investigation result can clarify the enforcement of latest building design codes on design engineering and/or construction practice.

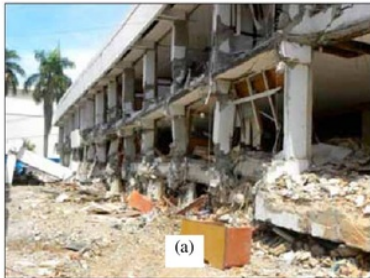
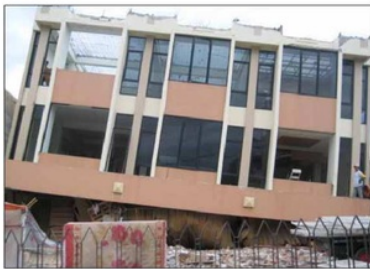
The 7.6 Mw Western Sumatera-Indonesia earthquake had caused significant damage to many reinforced concrete (RC) buildings, including both older and newer buildings. Examples of collapsed multi-story RC buildings in Padang city are shown in Fig. 1. This indicated that enforcement of building codes on buildings built prior to 2009 was lacking in Padang which resulted in deficiencies in design engineering and/or construction practice.

Fig. 1 Example of collapsed buildings; (a) A collapsed 3-story government building; (b) First story failure of a 3-story shop-house [1]

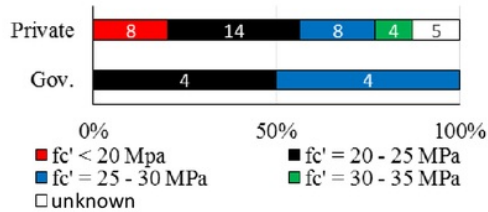
1) *Concrete Material:* For RC buildings in the high seismic risk area, the Indonesian concrete design code [3] has provisioned the minimum concrete compressive strength (f_c') to be 20 MPa. However, eight private buildings (20%) did not meet this requirement, as shown in Fig. 6. These buildings applied concrete with the standard of K-225 (cubical compressive strength of 225 kg/cm²) which corresponded to cylindrical compressive strength (f_c') of 18 MPa.

Fig. 6 Investigation results in concrete compressive strength

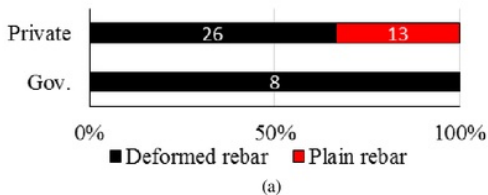
2) *Rebar Material:* The Indonesian concrete design code [3] has regulated that deformed bar should be used as reinforcement. The plain bar is allowed to use only for spiral reinforcement. However, thirteen private buildings (33%) applied plain rebar for longitudinal reinforcement, as shown in Fig. 7(a). Furthermore, thirty five private buildings (90%) and five government buildings (62%) applied plain rebar for transverse reinforcement, as shown in Fig. 7(b). Plain rebar is not recommended especially for flexural reinforcement because it has very low bonding without mechanical interlocking with concrete.

Fig. 7 Investigation results on types of rebar used as reinforcement; (a) Longitudinal reinforcement; (b) Transverse reinforcement

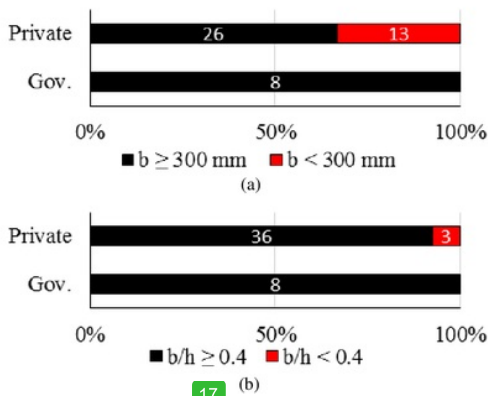
1) *Dimensions of Column*: Column with too small dimensions can lead to “weak column-strong beam” mechanism which may cause story collapse of buildings. The Indonesian code [3] regulates that the shortest cross-sectional dimensions of column shall be not less than 300 mm and the ratio of the shortest cross-sectional dimension to perpendicular dimension shall be not less than 0.4. However, thirteen private buildings (33%) did not meet the requirement for the minimum cross-sectional dimensions and three private buildings (8%) did not meet requirement for the ratio of cross-sectional dimensions, as shown in Fig. 8(a) and 8(b).

Fig. 8 Investigation results on cross-sectional dimensions of the column; (a) Minimum cross-sectional dimension; (b) Ratio of cross-sectional dimensions

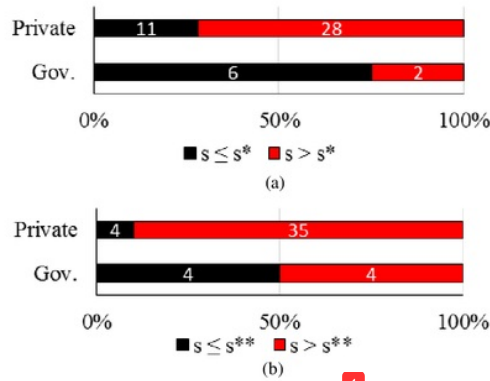
Fig. 11 describes the requirements for the maximum spacing of transverse reinforcement in accordance with the Indonesian code [3]. The investigation results in Fig. 12(a) show that twenty eight private buildings (72%) and two government buildings (25%) did not meet the requirement for the spacing of transverse reinforcement in the hinge region. Moreover, thirty five private buildings (90%) and four government buildings (1%) did not meet the requirement for the spacing of transverse reinforcement in the non-hinge region, as shown in Fig. 12(b).

Fig. 12 Investigation results on the spacing of transverse reinforcement in the column; (a) Hinge region; (b) Non-hinge region

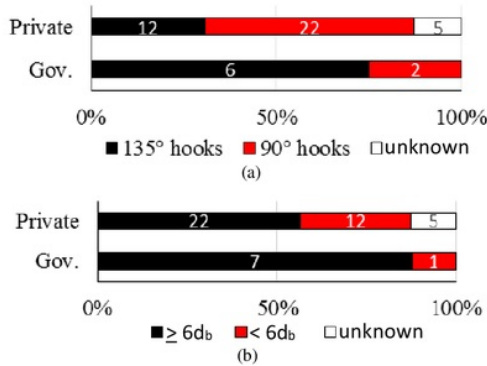
The Indonesian code [3] also stipulates application of seismic hooks with 135° or more and the length not less than $6d_b$ (transverse bar) to column stirrups. However, in real construction, twenty two private buildings (56%) and two government buildings (25%) applied 90° hooks, as shown in Fig. 13(a). Moreover, twelve private buildings (31%) and one government building (12%) applied hooks of column hoops with the length less than $6d_b$, as shown in Fig. 13(b).

Fig. 13 Investigation results on details of seismic hooks of column stirrups; (a) Angle of hooks; (b) Length of hooks

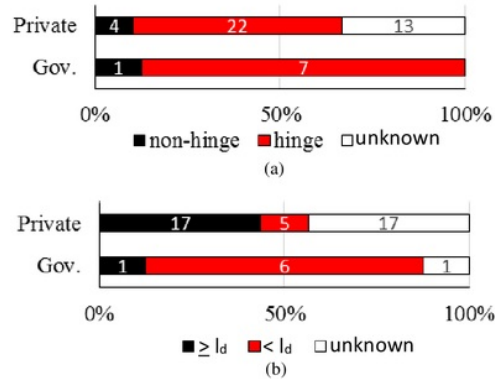
Fig. 14(b) shows that five private buildings (13%) and six government buildings (75%) did not meet the requirement for the length of lap splice. In many buildings, the length of

lap splice was conventionally defined as $40d_b$ (longitudinal bar) which tends to give smaller length than Equation (3) or (4).

Fig. 14 Investigation results on lap splice in the column; (a) Location of splice; (b) Length of splice

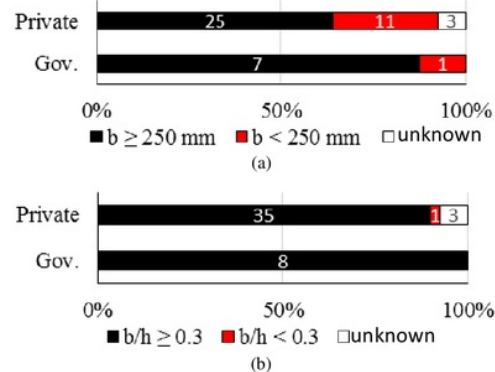
1) *Dimensions of Beam:* The Indonesian code [3] has provisioned that width of the beam shall be ≥ 250 mm, and the ratio of width to depth shall be ≥ 0.3 . However, eleven private buildings (28%) and one government building (12%) did not meet the requirement for the minimum width, as shown in Fig. 15(a). Moreover, one private building (3%) did not meet the requirement for the ratio of width to depth, as shown in Fig. 15(b).

Fig. 15 Investigation results on cross-sectional dimensions of the beam; (a) Minimum width; (b) Ratio of width to depth

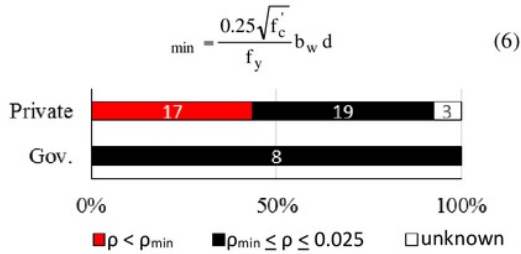
2) *Longitudinal Reinforcement in Beam:* According to the Indonesian code [3], the minimum area of tensile or compressive reinforcement in beam shall not be less than the maximum value obtained by Eq. 5 and Eq. 6, and the reinforcement ratio shall not exceed 0.025. However, seventeen private buildings (43%) did not meet the requirement of the minimum reinforcement ratio, as shown in Fig. 16.

Fig. 16 Investigation results on the ratio of longitudinal reinforcement in the beam

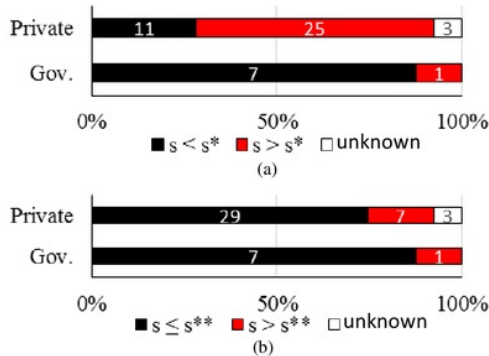
3) *Transverse Reinforcement in Beam:* Requirements for the maximum spacing of transverse reinforcement in the beam in the Indonesian code [3] are described in Fig. 17. The investigation results in Fig. 18(a) shows that twenty five private buildings (64%) and one government building (12%) did not meet the requirement for the spacing of transverse reinforcement in the hinge region. Furthermore, seven private buildings (18%) and one government building (12%) did not meet the requirement for the spacing of transverse reinforcement in the non-hinge region, as shown in Fig. 18(b).

Fig. 18 Investigation results on the spacing of transverse reinforcement in the beam

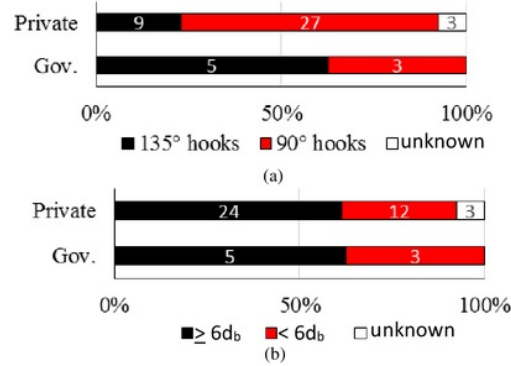
Seismic hooks with 135° or more and the length not less than $6d_b$ (transverse bar) shall be applied to beam hoops. However, in real construction, twenty seven private buildings (69%) and three government buildings (37%) applied 90° hooks, as shown in Fig. 19(a). Moreover, twelve private buildings (31%) and three government buildings (37%) had the length of hooks of stirrups less than $6d_b$, as shown in Fig. 19(b).

Fig. 19 Investigation results on details of seismic hooks of beam stirrups

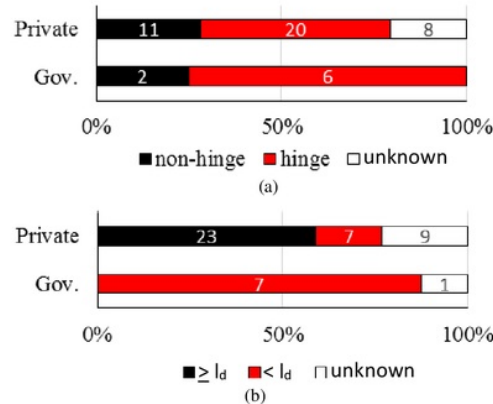
4) *Lap Splice in Beam:* The provisions for lap splices in the beam are similar to those on the column as explained in Section III.B.4. The investigation results in Fig. 20(a) shows that twenty private buildings (51%) and six government buildings (75%) applied lap splices in the hinge region. Fig. 20(b) shows that seven private buildings (18%) and seven government buildings (87%) had lap splices with lengths less than the required length (l_d). In many buildings, the length of lap splice in the beam was conventionally defined as $40d_b$ (longitudinal bar) which tends to give smaller lengths than required by the latest code [3].

Fig. 20 Investigation results on lap splice in the beam; (a) Location of splice; (b) Length of splice

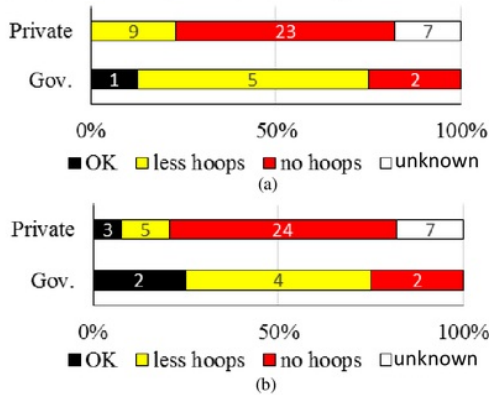
Fig. 21(a) shows the investigation result of hoop details in the exterior beam-column joints. Most of the investigated buildings did not satisfy the requirements for hoops in the exterior joint. For private buildings, twenty three cases (59%) contained no hoops in the exterior joints, while nine

cases (23%) contained hoops less than the requirements. For government buildings, five cases (62%) contained hoops less than the requirements, while two buildings (25%) contained no hoops.

Fig. 21(b) shows the investigation result of hoop details in the interior beam-column joints. Only three private buildings (8%) and two government buildings (25%) satisfied the requirements for hoops inside the interior joint. Other buildings contained no hoops or insufficient hoops to the interior joints. In construction practice, hoops in the exterior and interior joint were likely not to be applied or reduced to eliminate difficulties posed by rebar congestion.

Fig. 21 Investigation results on hoops in beam-column joint; (a) Exterior joint; (b) Interior joint

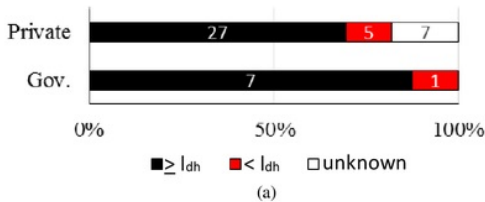
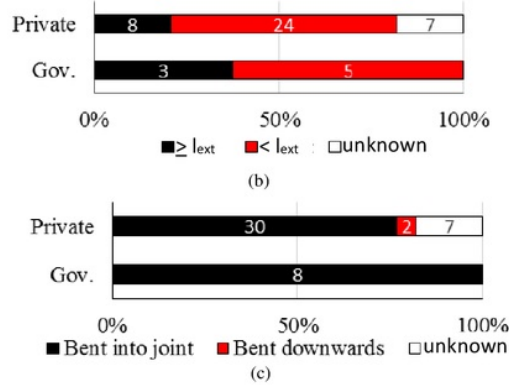
The end of rebar should be bent with a 90° hook, and the length of tail extension (l_{ext}) shall not be less than $12d_b$ (longitudinal bar). Many of the investigated buildings satisfied the requirement for the length of anchorage (l_{dh}), as shown in Fig. 22(a). However, many did not satisfy the requirement for the length of tail extension (l_{ext}). Fig. 22(b) shows that twenty four private buildings (61%) and five government buildings (62%) had the length of tail extension (l_{ext}) less than $12d_b$.

Fig. 22 Investigation results on hoops in beam-column joint; (a) Length of anchorage; (b) Length of tail extension; (c) Type of anchorage

The types of anchorage applied to the investigated buildings are shown in Fig. 22(c). It is widely known that the hooks should be bent into the joint (Fig. 23(a)). However, in two private buildings (5%), both top and bottom beam longitudinal reinforcements were bent downwards (Fig. 23(b)).

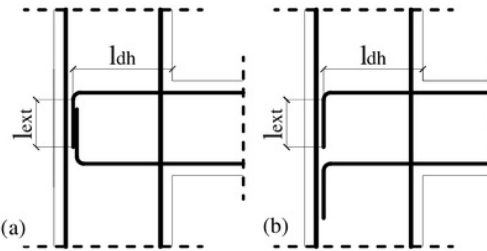
Fig. 23 Type of anchorage of beam rebar in exterior beam-column joint; (a) Bent into joint; (b) Bent downwards

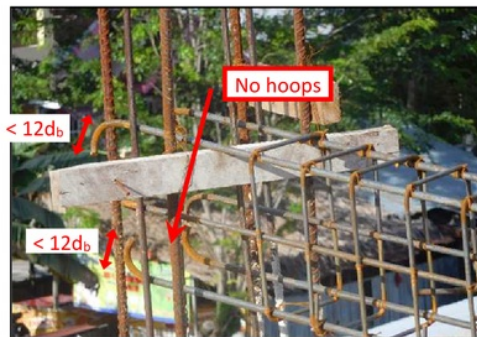
Fig. 24 shows typical deficiencies observed in exterior beam-column joints in which shorter tail extensions (l_{ext}) are applied to anchor beam reinforcement and no hoop is applied.

Fig. 24 Typical deficiencies in exterior beam-column joint
