THE 6TH CIVIL ENGINEERING CONFERENCE IN THE ASIAN REGION

RETROFITTING OF BUMIMINANG HOTEL BUILDING IN PADANG

Keywords: Earthquake, damage, retrofitting

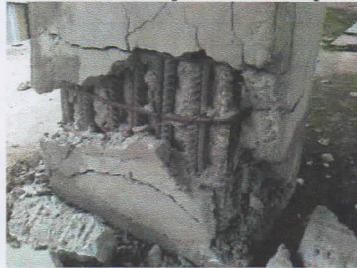
- Based on the actual condition and the analysis results, apart from the core area, there were relatively few direct columns and beams damage. The damage of columns and beams were not patterned and sporadic. The damage of columns and beams were mostly spalling of concrete at supports, however main reinforcing bars were not deformed.

Fig. 2 : Main column failure, reinforcing bars undeformed.

Most of the direct damage of beams and columns were due to overstress causing spalling of concrete. The damaged part was chipped and additional confinement was installed. For beams connected to the core area, where the main reinforcement was deformed, additional splices were provided apart from the additional confinement. For the reconcreting, Sikament LN was added to the concrete. The masonry walls along the perimeter of the building were reinforced with wire mesh on both sides of the wall and each r.c. window framing was installed. The masonry columns between two main r.c. columns along the perimeter of the building were replaced by r.c. columns embedded in the walls. The masonry walls between rooms

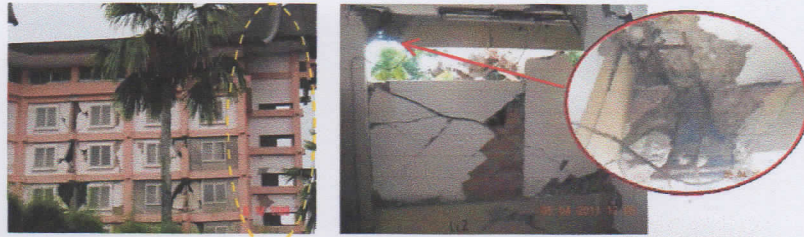
- The masonry columns between two r.c. columns along the perimeter of the building were only esthetical and were not properly anchored to the main structure. During the shaking, almost all masonry columns were heavily damaged. The masonry walls adjacent to those columns suffered substancial damage.
- Most walls on the ground floor were seriously damaged.
- There were two emergency stair shafts at both ends of the building. Many beams were damaged due to lack of confinement and improper detailing and poor concreting. Many of the masonry walls in the emergency stair shafts were also damaged.

Fig. 5 : Beam damage at right-side stair shaft

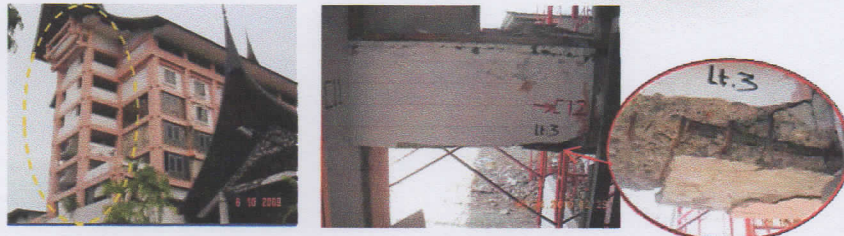
Fig. 6 : Beam damage at left-side stair shaft due to poor detailing and poor concreting

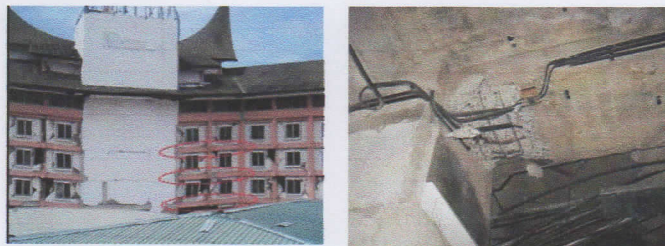
- As mentioned, the thin columns were crushed at the ground floor and caused settlement of approximately 70 cm. Beams and slabs connected to the thin columns were forced to deform causing overstress at the other end of the slabs and beams. However, only a few beam main reinforcement was yielded.
- Masonry walls between rooms suffered minor damage except the walls adjacent to the thin columns where the beams joining the core area were forced to deform.

Fig. 7 : Indirect damage

After the steel frame construction of the core is completed, the beams and slabs connecting to the core must be re-connected. 10 ton car jacks were used to restore the levels of the deformed beams and slabs.

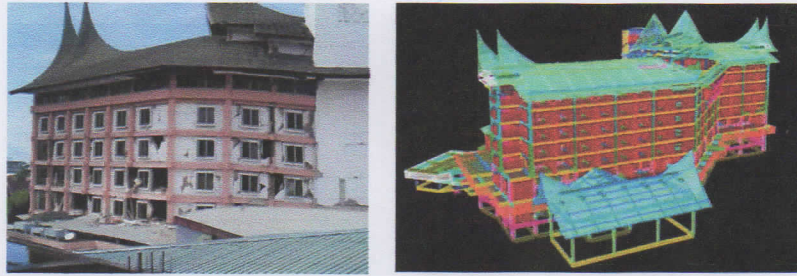
Fig. 8 : Bumiminang Hotel before retrofitting (left); 3D model analysis using ETABS NL v9.7 (right)

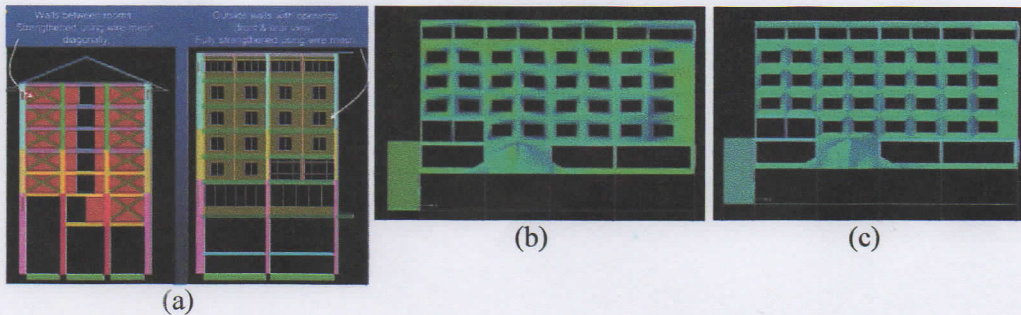
Fig. 9 : Retrofitting of walls using wire mesh (a); retrofitted walls, stresses in bricks did not exceed the allowable stress ($-0.35 \sim 0.133 \text{ N/mm}^2$) (b); stresses in plasters did not exceed the allowable stress ($-1.3 \text{ s/d } 3 \text{ N/mm}^2$) (c)

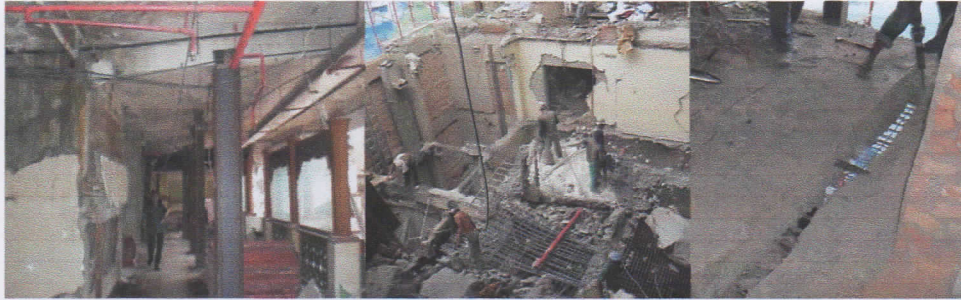
Fig. 10 : Temporary support using H profiles

Since alternative 1 is not feasible, the other option left is to demolish all the core area and rebuild it. For that purpose there was a need to temporarily support all the beams and the slabs connecting to the core area from the ground floor up to the machine room. H steel profiles were used for the purpose. Before demolishing the core area, all beams and slabs were separated from the core. To speed up the retrofitting, it was decided to rebuild the core area with steel frames and light weight blocks as walls.

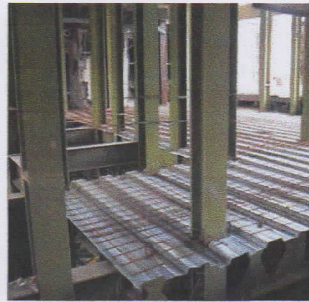
Fig. 14 : Slab at core area

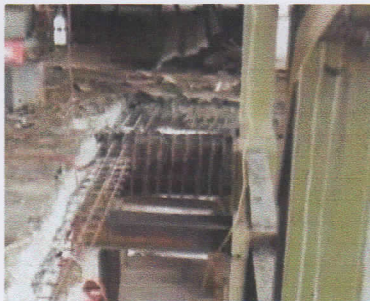
Fig. 16 : Connecting concrete beams into steel beams/columns at core area

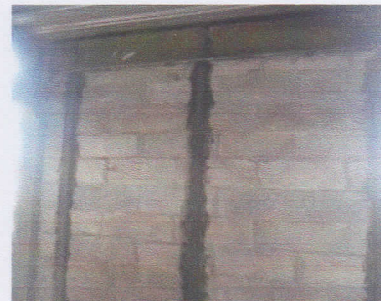
Fig. 17 : Construction of walls at core area

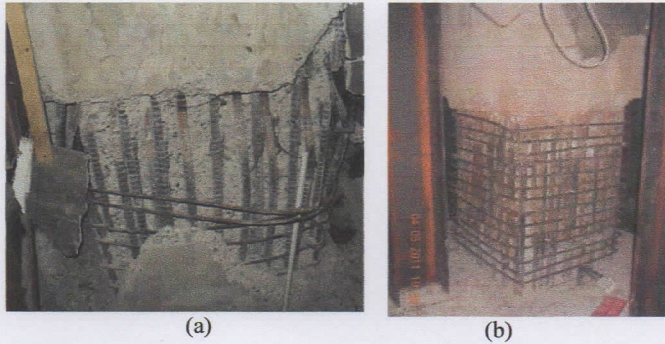
Fig. 18 : Retrofitting of damaged column outside core area - damaged column (a); additional confinement (b).

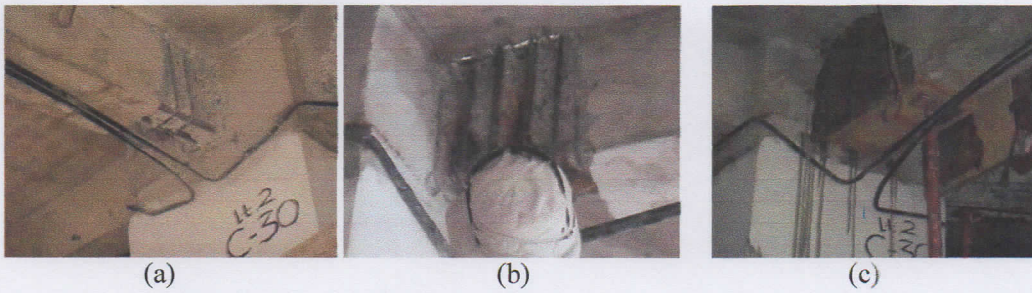
Fig. 19 : Retrofitting of damaged beam – damaged beam (a); additional confinement (b); re-concreting (c).

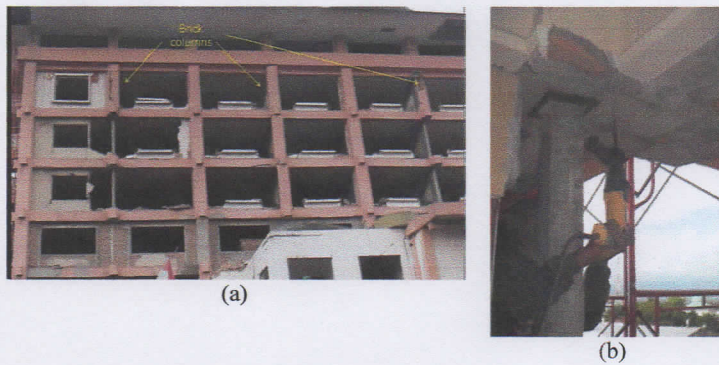
Fig. 20 : Replacing masonry column with practical column (a); installation of practical column (b).

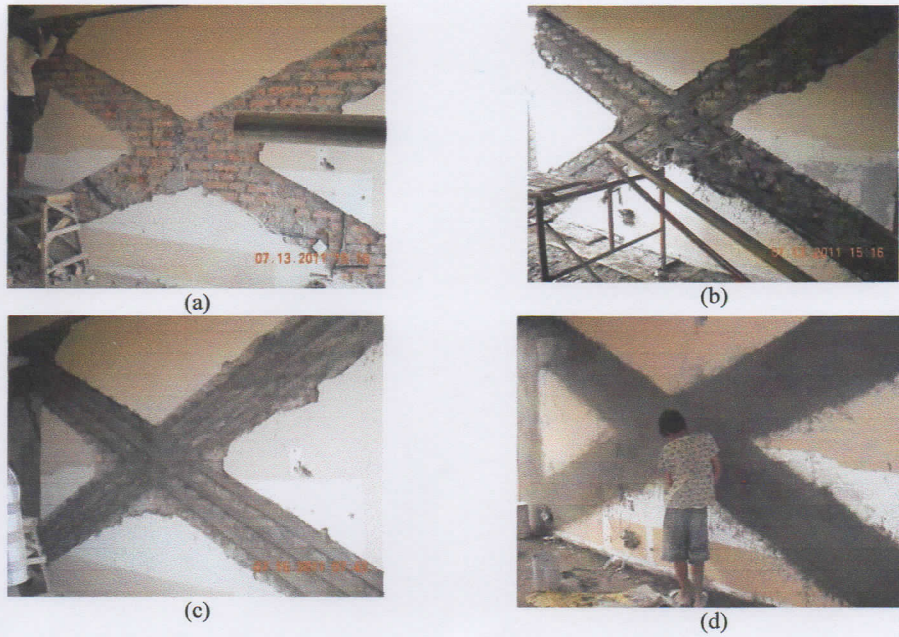
Fig. 21 : Retrofitting of masonry walls between rooms using diagonal wire mesh strips on both sides of the wall: peeling off wall plaster (a); thin bed mortar for wire mesh (b); wire mesh installation (c); re-plastering (d).

were reinforced using diagonal wire mesh strips on both sides of the wall. Sikament LN was added for the mortar. To fill wide cracks, Sikagrout 215 was applied. Smaller cracks were filled with Sikadur 752 RT. The structure retrofitting was completed within 10 months.

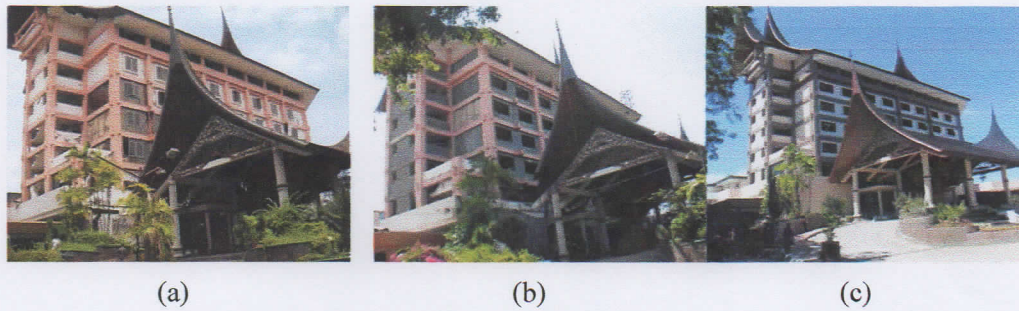
Fig. 22 : Front view - before retrofitting(a); after retrofitting (b); after repainted (c).

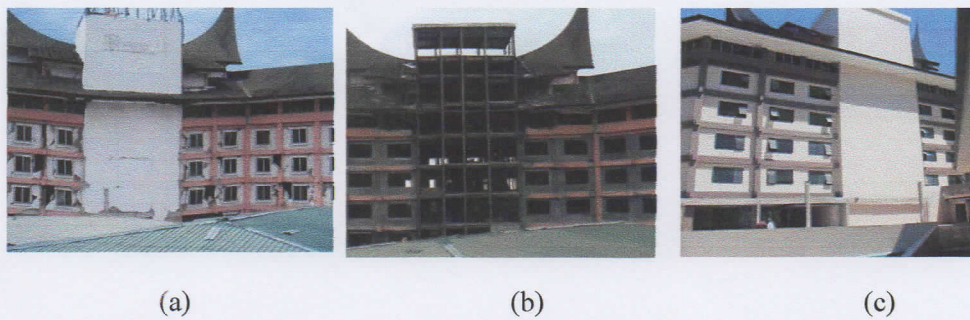
Fig. 23 : Core area - before retrofitting (a); after retrofitting (b); after repainted (c).
