JAABE

This paper describes the effects of nonstructural brick walls on the seismic performance of reinforced concrete (R/C) buildings. Experimental and analytical studies were conducted on two buildings: one of which collapsed and the other suffered moderate damage due to the 2007 Sumatra, Indonesia earthquakes. A brick wall was extracted from the moderately damaged building and transported to Japan from Indonesia to experimentally evaluate its seismic performance. Two R/C one-bay frame specimens were constructed, and the imported wall was installed in one of the specimens. Comparing the seismic performance of specimens with and without the brick wall through quasi-static cyclic loading tests, wall contributions were quantitatively evaluated. Moreover, the seismic performance of the earthquake-damaged Indonesian buildings was evaluated numerically considering the findings of the tests. The analyses revealed a possible reason for the collapse of one of the buildings due to the earthquakes.

Keywords: masonry infill; numerical analysis; reinforced concrete; seismic loading test; 2007 Sumatra, Indonesia earthquakes

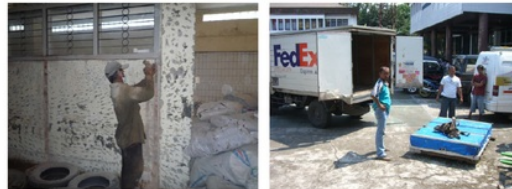
(a) Extracting Wall. (b) Transporting Wall.
Photo 4. Preparation of Brick Wall Specimen

To experimentally clarify the structural contributions of nonstructural brick walls to the seismic performance of R/C buildings, a brick wall was extracted as a test specimen from the surviving building, as shown in Photo 4(a). The size of the brick wall was about 1500 x 1500 mm. Then, it was transported to Toyohashi University of Technology, as shown in Photo 4(b).

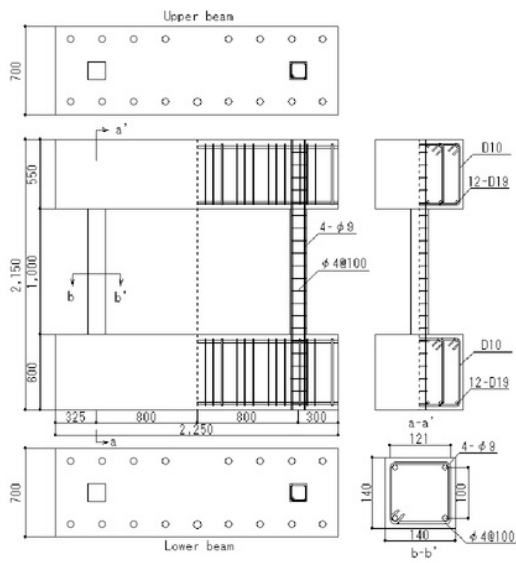
Fig.3. Detailed Drawing of BF Specimen

The R/C frames represent the first story of the surviving building shown in Photo 3 and Fig.2. The cross-sectional dimensions of the columns were 140 x 140 mm, with 4-φ9 longitudinal rebars and 2-φ4@100 transverse hoops. The clear height of columns was 1000 mm. Figure 3 shows the configuration and bar arrangements of the BF specimen.

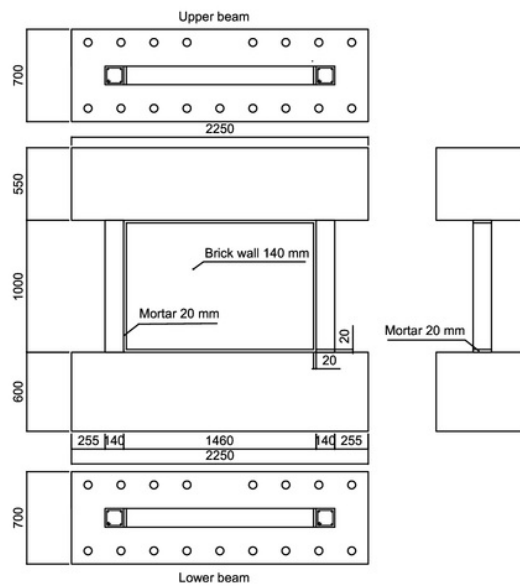
Fig.4. Detailed Drawing of IF Specimen

The imported brick wall was installed in one of the R/C frame specimens, as shown in Photo 5(a), after it was cut to dimensions of 1420 mm in width x 960 mm in height, as shown in Photo 5(b). In this specimen, however, the wall thickness of 140 mm was not reduced because of technical difficulties related to scale reduction. Mortar was produced with a volume ratio of cement : sand : water = 1 : 4 : 0.5, and was applied between the main frame and inserted wall as

a joint material. The thickness of the mortar joint was 20 mm, as shown in Fig.4. Initial slight damage was observed in the infilled wall, as shown in Photo 6.

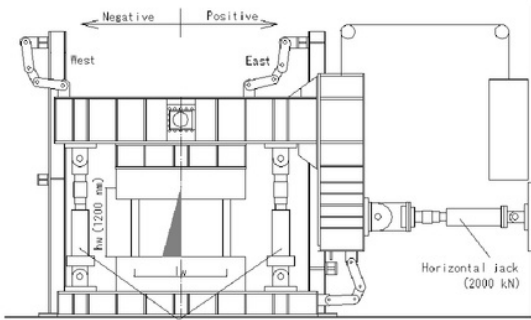
Fig. 5. Schematic View of Test Set-up

The specimens were tested at the testing facility of the Toyohashi University of Technology. A schematic representation of the experimental set-up is shown in Fig.5. One horizontal hydraulic jack (2000 kN) and two vertical ones were equipped for the loading system.

The specimens were subjected to a constant vertical load of 183.4 kN ($\approx 0.24 \times$ column sectional area \times compressive strength of concrete) based on

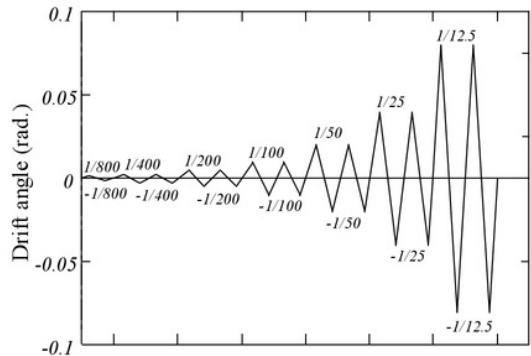
Fig. 6. Lateral Loading History

the calculated weight of the surviving building. Then, reversed cyclic lateral loads were applied to the specimens. Drift angle R (rad.), ratio of lateral displacement to column height, was used to control incremental loading. Lateral loading program was initial cycle to $R = 1/800$ followed by two cycles to $R = 1/400, 1/200, 1/100, 1/50, 1/25,$ and $1/12.5$. When the specimens failed, however, loading was stopped. Figure 6 shows the lateral loading history. The shear span to depth ratio ($= h_w/l_w$ in Fig. 5.) of the specimens was maintained at 0.75 throughout the tests so that lateral loads were applied at an assumed second floor height of 1200 mm.

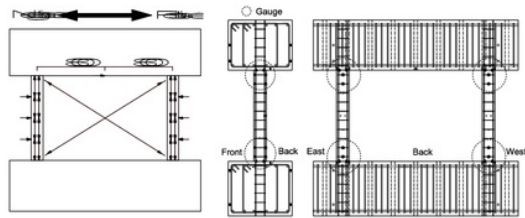
Fig. 7. Measurement

The horizontal, vertical, and diagonal relative displacements of the specimens were measured with transducers, as illustrated in Fig. 7.(a). Strains of longitudinal rebars and hoops were also measured using strain gauges, as illustrated in Fig. 7.(b). Initiated cracks, crack propagation, and major crack widths were observed at every peak and residual drift, to identify the failure mechanism of specimens.

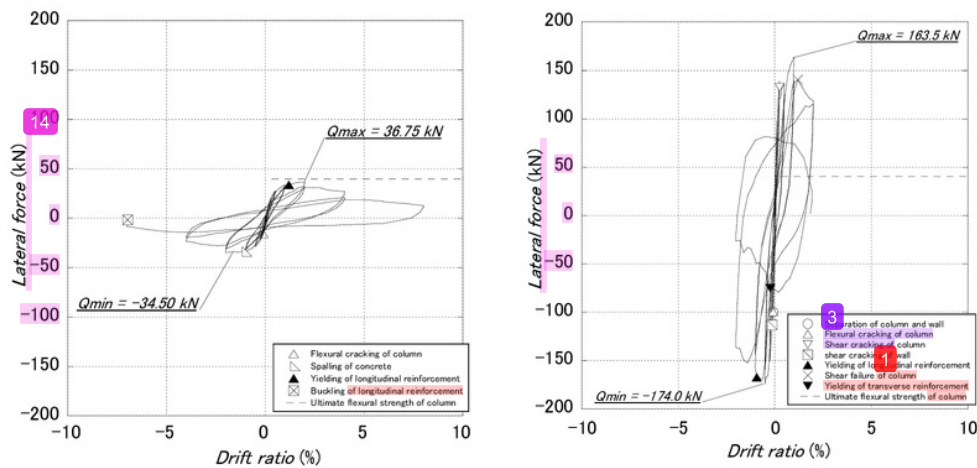
Fig.9. Lateral Force-Drift Ratio Relationships

Fig. 9. compares the lateral force vs. drift ratio, R relationships between the specimens. The maximum lateral strengths of 36.8 kN and 174.0 kN were observed at 2.0% and 0.5% drift ratios for BF and IF, respectively. The deformation capacities, which were defined as a deformation where post-peak strength dropped to 80% of the peak strength, were 2.8% and 1.6% for BF and IF, respectively.

After installing the nonstructural brick infill, strength increased to 4.7 times, but ductility decreased to about half.

(a) BF Specimen.

(b) IF Specimen.

The brick wall installed in a R/C frame significantly increased the lateral strength of the overall frame. The incremental strength due to the wall was briefly evaluated at the maximum strength in Fig. 9.(b) by Eq. (1). However, this equation considered only the difference between overall strengths neglecting interactions between the columns and wall. As a result, the averaged shear strength of the brick wall was 0.73 N/mm^2 , which was applied to an analytical study in the following.

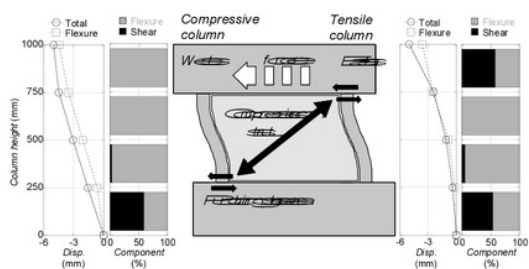
Fig. 10. Punching Shear Action on Columns

On the other hand, the ductility of the R/C frame increased upon installing the brick wall. This was because an inclined compression strut was formed in the panel when it was subjected to shear deformation by the surrounding frame, as shown in Fig. 10. As a consequence, a high punching shear acted on the

bottom/top of compressive/tensile column. In this figure, the distributions of lateral displacements and deformation components along the column height were also shown at the maximum strength. It was found that the shear deformation was clearly dominant at the bottom/top of compressive/tensile column.

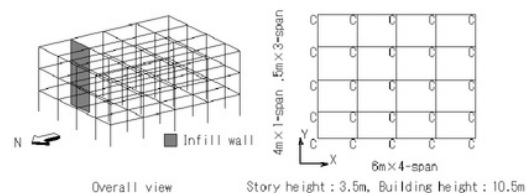
Fig. 11. Structural Brief of the Collapsed Building

The structural details are summarized in Fig. 11. and Table 4. for the collapsed building and in Fig. 12. and Table 5. for the surviving one, respectively. As shown in Table 4., however, member details of the collapsed building excluding the first story column could not be collected before the building was demolished. Therefore, column details in the second and third stories were assumed to be identical to those in the first story, and beam details were referred to a typical beam in the other building (G1 in Table 5.).

Incremental lateral loads were applied in the western direction (refer to Figs.11. and 12.), to which the collapsed building had toppled as shown in Photo 1. Table 6. gives the applied distributions of lateral loads along the building height, which were calculated on the basis of the Japanese building design code⁴⁾.

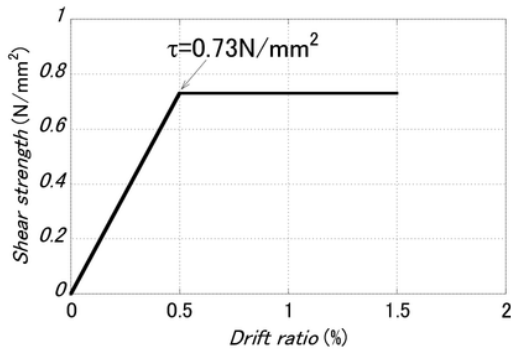
Fig.13. Modeling of Infill Performance

Moreover, in the cases of analyses considering infill walls, their behavior was represented by bilinear elements with lateral strengths equivalent to the experimental result, as shown in Fig.13. Lateral strength of each infill was evaluated by multiplying its cross-sectional area by the averaged shear strength of 0.73 N/mm².

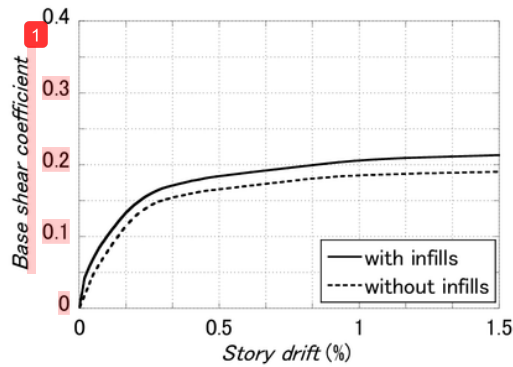
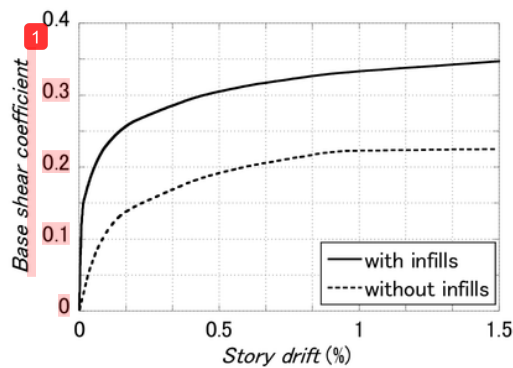
Fig.14. Comparison of Performance Curves

Fig.14. compares the base shear coefficient vs. the first story drift relationships of both buildings with and without infill walls. The difference between the lateral strengths of the buildings was less than 20% when neglecting infills. With infills, however, the strength of the surviving building exceeded that of the collapsed one by more than 50% at a 1.5% drift level approximately equivalent to the deformation capacity of the IF specimen (Refer to Section 5.2). This result means that nonstructural brick infill walls should be considered in a seismic performance evaluation of this kind of structure. In particular, the case of the surviving building, they seemed to contribute significantly to reducing structural damage under the earthquakes, which is a possible reason for the difference of damage grade observed between two similar buildings.

(a) Collapsed Building.

(b) Surviving Building.

2. Pushover analyses were also conducted for both of the earthquake-damaged buildings based on the test results. It was found that nonstructural brick infills significantly increased the strength of the surviving building, which was more than 1.5 times that of the collapsed one at the ultimate state. This is a possible reason why different damage grades were observed between two similar buildings.
