The Behaviours of the Brick-Masonry Infilled RC Frame Structure under Reversed Cyclic Lateral Loading

Maidiawati[#], Yasushi Sanada^{*}, Jafril Tanjung[†]

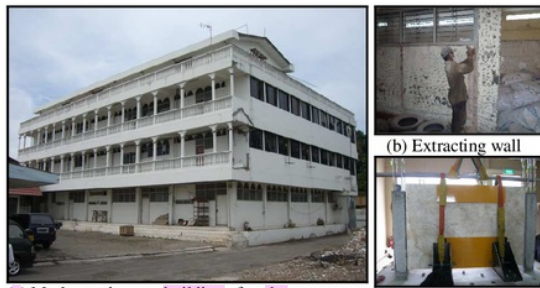
Fig. 1 Preparation of brick wall specimens

Especially for the IF specimen, as shown in Fig. 1(b), the brick infill wall panel was extracted from the surviving building and transported to Japan. Furthermore, it brick wall panel was installed in the RC frame specimen in the dimension of 1,420 mm width and 960 mm height. Noting that the thickness of the brick wall in IF specimen was remaining in original size, i.e., 140 mm. Due to technical difficulties, the wall thickness was not scaled down. The mortar was blended from cement, sand and water in volume ratio as 1:4:1.3. The mortar inserted between the brick wall and the RC frame as interface material. The mortar thickness was approximating 20 mm as it is shown in Fig. 2(b).

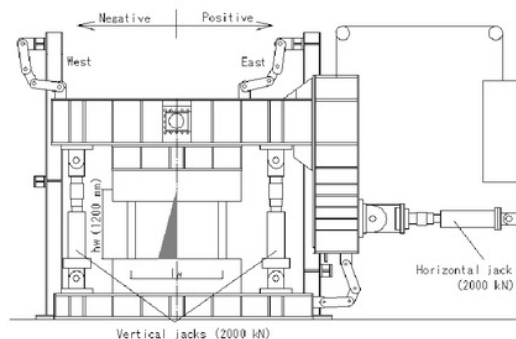
Fig. 3 Schematic view of a test set-up

The experimental works were conducted by utilizing the structural testing facilities in Toyohashi University of Technology, Japan. The experimental set-up is schematically shown in Fig. 3. The loading system was applied by one horizontal and two vertical jacks. Each jack capacity is 2,000 kN. Two constant vertical forces of 183.4 kN were loaded to specimens which were calculated based on the weight of the RC building. These vertical forces were equivalent to an approximation of 24% of the sectional area of column multiplied by the compressive strength of concrete of the survived RC building. The applied lateral reversed cyclic loading to the specimens referred to FEMA 461 standard [13]. The load increment was in drift angle control R, where drift angle R in degree, i.e., a ratio between the lateral displacement and the column height. The initial cycle is $R = 1/800$ and followed by two cycles for every $R = 1/400, 1/200, 1/100, 1/50, 1/25,$ and $1/12.5$ as is shown in Fig. 4. During experimental works, the shear-span (h_w) to depth (l_w) ratio of the specimens was always maintained at 0.75. The experimental work was stopped when the specimen failed.

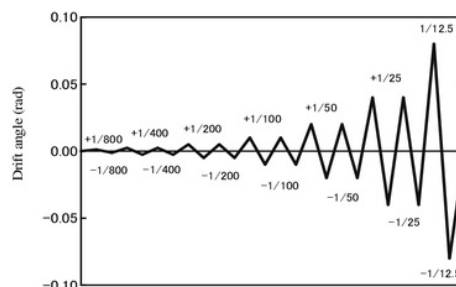
Fig. 4 Lateral loading history

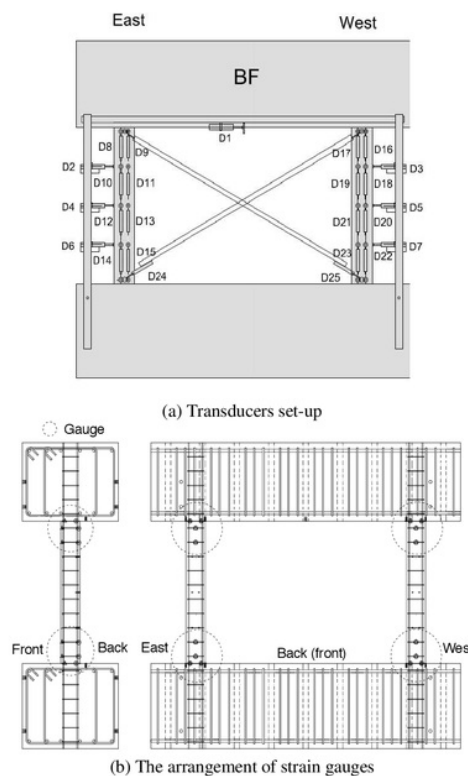
Fig. 5 Measurement

All the displacements were measured by the displacement transducers and recorded by the portable data logger. The set-up of transducers on the specimens is shown in Fig. 5(a), i.e., transducers codes D1 to D25. These displacements include the horizontal, vertical and the diagonal relative displacements, respectively. Besides of them, the strains of reinforcements were measured by the strain gauges. The arrangement of the strain gauges pasted on the rebars is shown in Fig. 5(b). During applied loading, the cracks occurred on the specimens were observed, such as cracks on columns and the brick walls as well. These cracks were marked at the initial and maximum positions.

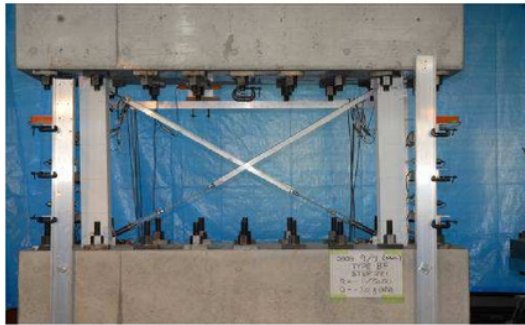
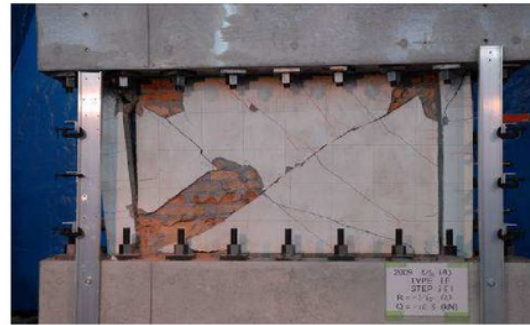
(a) Bare frame specimen

(b) Infilled frame specimen

Fig. 6 Remarkable damage during the cycle $R=1/50$

The following is the failure mechanism for the BF specimen. The initial flexural crack was observed at the top of the compressive column within $R=1/800$. While within $R=1/400$, flexural cracks have appeared at the top and the bottom of the both of columns. The cracks were continued propagating in these both of column within $R=1/200$. The initial crushing of the concrete occurred at the bottom of the compressive column has been appearing at $R=1/100$. When the $R=1/50$, the initial yielding of longitudinal and transverse reinforcements was detected. The cover of concrete of the column destroyed within $R=1/25$ and the lateral strength of columns started to degrade. Finally, within $R=1/12.5$, buckling of longitudinal reinforcement appeared at the tensile column, and therefore the specimen lost its axial resistance.

For the IF specimen, initial flexural crack was observed at the top of the tensile column during the first cycle. Separation cracks around the wall and shear crack on the brick wall were also observed during this cycle. Flexural cracks at the top and middle of the tensile column detected within $R=1/400$. Initial shear at the top of the tensile column appeared within $R=1/200$. The flexural and shear cracks in both of the columns and wall developed and during these cycles. Initial yielding of longitudinal rebar was

observed within $R=1/100$. Remarkable damage on the specimen was occurred within $R=1/50$ such as shear failure at the top of the tensile, buckling of longitudinal rebar, initial yielding of the top, spalling of cover concrete of column and spalling of plaster of the wall. After the shear failure of columns, the lateral strength of specimen degraded and then specimen lost its axial resistance. Fig. 6 shows the comparison of the condition of for both of specimens at the cycle $R=1/50$.

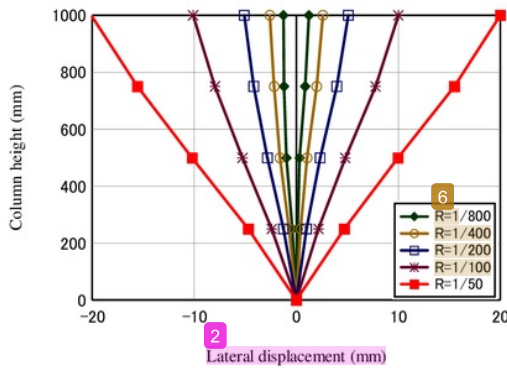
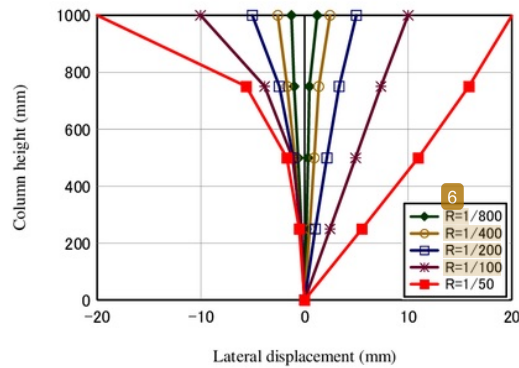
(a) BF specimen

(b) IF specimen

Fig. 7 Lateral displacement of east column

A different type of column-sway along the column height was observed on the BF and IF specimens under reversed lateral load. On the BF specimen, column-sway was relatively same in reversed directions since the first cycle to final loading as shown in Fig. 7(a). In the case of the IF specimen, the lateral displacement of the column in reversed direction was relatively same until the cycle $R=1/400$, however, from the cycle, $R=1/200$ column has a different lateral displacement shape along its height in the reversed lateral direction as shown in Fig. 7(b). The infill constrained the boundary column so that it affected to the flexibility of columns. The lateral force along the column height due to punching shear on infill also altered the lateral displacement of the boundary columns. Similar response of column-sway was also observed on the west column of the IF specimen.

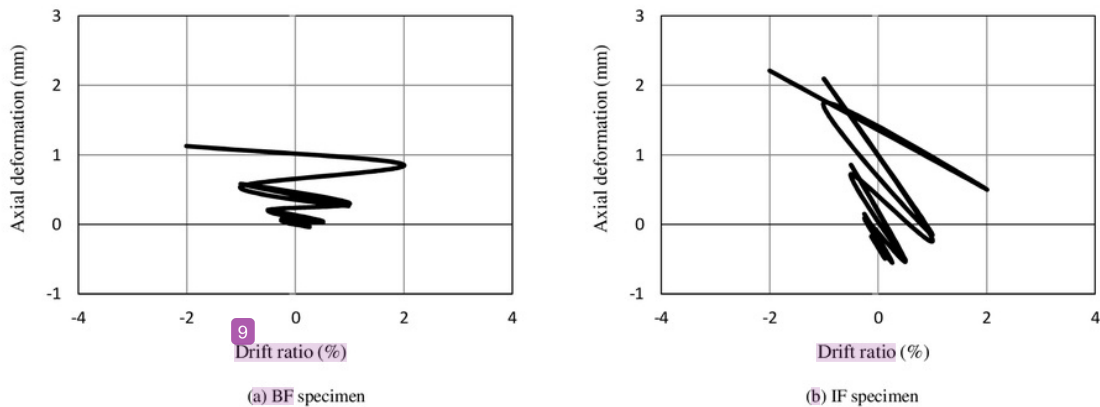
Fig. 8 Axial deformation of the East column and drift ratio relationship

Fig. 8 shows the comparison of axial deformation of the east-column for the BF and IF specimens. When the reversed lateral load applied on the upper beam of the IF specimen, the punching force in the infill transferred the additional compressive/tensile axial force on the east-column. It is shown in Fig. 8. This additional axial force caused the axial deformation on the east-column becomes different when it is compared to the axial deformation of the east-column of the BF specimen. The axial deformation on the west-column of the IF specimen was also different from that of the west-column of the BF specimen.

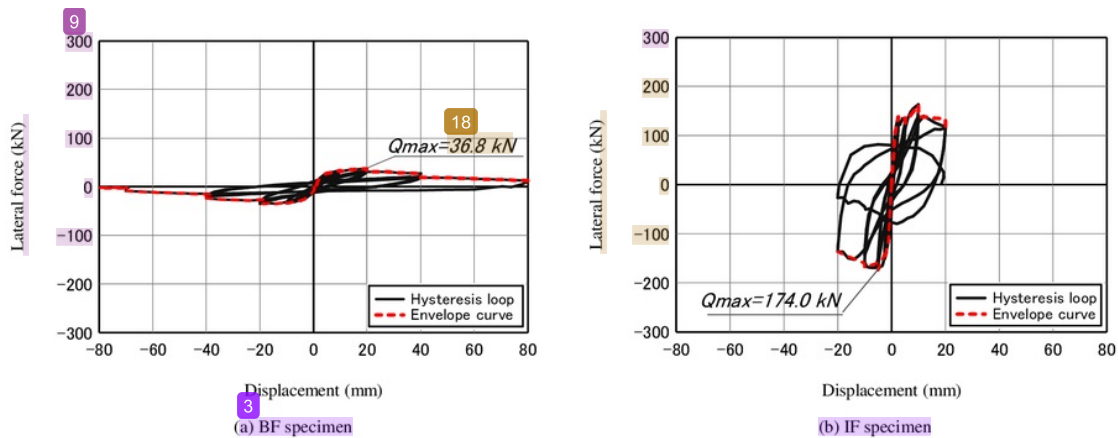
Fig. 9 Lateral force–drift ratio relationships of the specimens with envelope curve.

Fig. 9 shows the comparison of the lateral force-lateral displacement relationship curves between the BF and IF specimens, including their envelope curves. The envelope curve represents the peak values of the lateral force in each cycle of the hysteresis loop. By comparing the lateral force of both specimens, the maximum force of the IF specimen

was approximately 4.7 times greater over BF specimen, but its ductility decreased up to about half. The maximum lateral force of the BF specimen was observed 36.8 kN at the 20 mm displacement. However, for the IF specimen, the maximum force reached 174.0 kN at the displacement of 5.02 mm. The deformation capacity for the BF specimen is 28 mm, while for the IF specimen is 18 mm. The deformation capacity is a drift ratio at which the post-peak force dropped to 80% of the peak force. The deformation capacities of the IF specimen were noticed with shear failure at the top of the column, i.e., on the tensile side caused by the punching shear from the brick infill wall. This phenomenon is clearly shown in Fig. 6(b). Indeed, these results are agreeing with the progressive failure processes of the IF specimen, where the deformation capacity of the IF specimen is observed prior to the full compression failure. These experimental results stated that the presence of the brick infill wall increases the lateral strength of the RC frame structure, but it decreased its ductility.

In the lateral force-displacement curve, the area within the hysteresis loop illustrates the dissipated energy [14]. By calculating the area enclosed by the hysteresis loop of the lateral force-displacement curves in Fig. 9, the comparison of the energy dissipated between the BF and IF specimens, may be drawn as is shown in Fig. 11. The brick infill in the IF specimen significantly increased the energy dissipation of the RC frame specimen. This result indicates that it could make the RC structure become less vulnerable with respect to the earthquake.

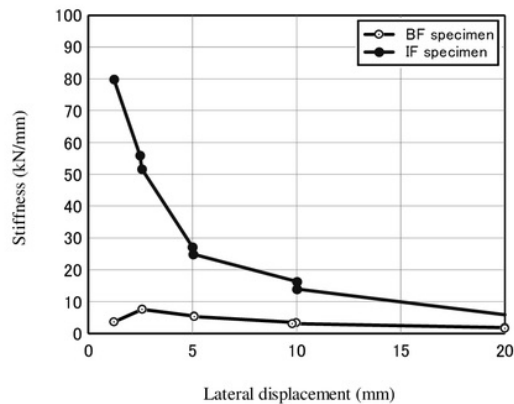
Fig. 10 Lateral stiffness

Fig. 10 shows the comparison of the lateral stiffness of the BF and IF specimens. It can be seen that the IF specimen exhibits the greater stiffness than the BF specimen. When the plastic hinge started developing at the ends of columns, the stiffness of the IF specimen drastically degraded.

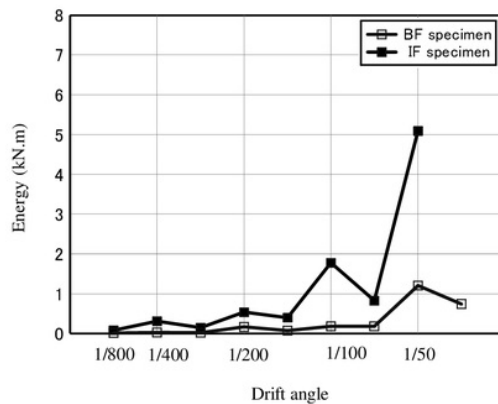
Fig. 11 Comparison of dissipated energy
