**SIBE2013**

**The Second International Conference on Sustainable  
Infrastructure and Built Environment**

## **Slope Stability Analysis Following Maninjau Landslide 2013**

**Abdul Hakam, Febrin A Ismail, Fauzan, Bambang Istijono & Ricky Arnaldo**

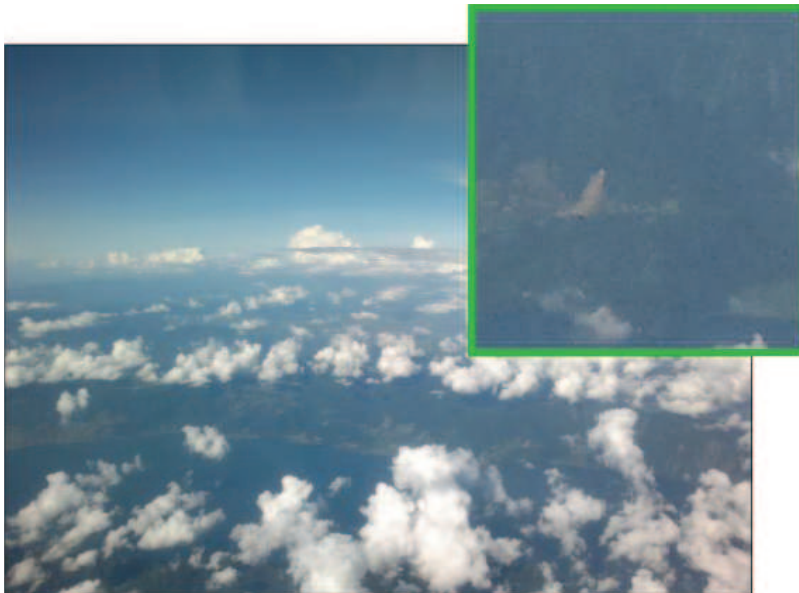
**Figure 2.** Maninjau landslide spot

The Landslide in Maninjau on 26-01-2013 happened in the dawn has taken the 22 lives. This Galodo happened in the hillside of Maninjau lake area.

Maninjau lake area has been recognised as landslide prone area. In West Sumatra earthquake on 30-09-2009, these are lansdslide in many spot in this area. However, the Maninjau Lanslede on 26-01-2013 took place in a new hill spot that has no landslide experience before.
