International Conference on Construction Industry,
Facilities and Asset Management
November 22-23, 2012, Padang - Indonesia

'GALODO' PADANG 2012: CAUSES AND PREVENTION

Abdul Hakam, Febrin A Ismail and Fauzan
Disaster Study Centre of Andalas University

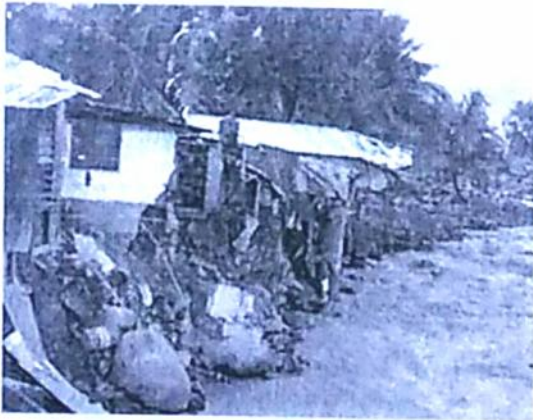
Figure 1. Scouring on the the river bang of Batang Kuranji due galodo I

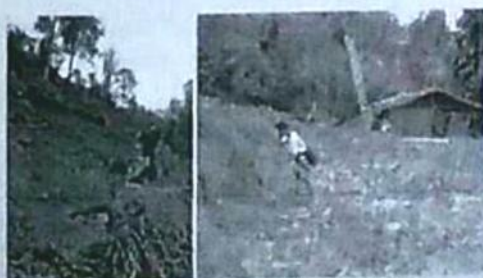
Figure 4. Post landslide condition

Although the actual location there are many large rocks (boulder), but the behavior of the soil dominates the slope stability. During the landslide the boulders were moving together with the mudflow.

The slope geometry data has been taken from the location of Padang Galodo II (Figure 4). The undisturbed soil samples was also has been brought from the landslide area on 2 points. Based on survey data on location the slope representation is then performed on the slopes (Figure 5). Batu Busuk hillside is categorized as a steep slope since the slopes have average angle more than 45 degrees.

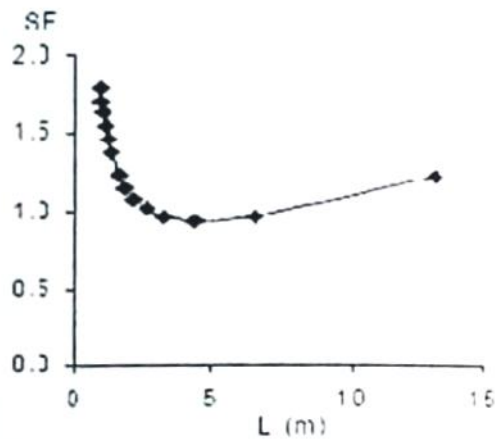
a. Direct shear Test data

b. Unconfined Compression Test data

Figure 6. The value of the safety factor for the length of the different collapse

Based on the slope geometric and soil parameters obtained, it can be seen that the biggest of slope angle is 60 degrees. The related soil parameters is taken from the soil samples 1. Those soil data then are used to simulate the flat failure surface in slope stability analyses. The results show that the slopes are still in a actually location in a critical condition, with the lowest safety factor of about 1 (Figure 6). This indicates that the slopes have potential to slide down.

The critical depth also calculated by assuming that the slope behaves completely dominated by the soil cohesion. The result shows the depth of the slope on the normal state (no rain) is 4.5m, while in the rain, to be 1.1 m. This means that in normal conditions, disturbance till the depth of 4.5m from the surface can lead the slope to be unstable condition. But in a worse condition and wet, then the interference with a depth of 1.1m has led to unstable slopes and landslides.
