Common Structural Details and Deficiencies in Indonesian RC Buildings: Preliminary Report on Field Investigation in Padang City, West Sumatra

Syafri Wardi^{#†}, Yasushi Sanada[#], Michihiro Kita[#], Jafril Tanjung^{*}, Maidiawati[†]

In this study, a field investigation was conducted to inspect common structural details and deficiencies in newly constructed multi-story RC buildings in Padang. The investigation result can clarify the enforcement of latest building design codes on design engineering and/or construction practice.

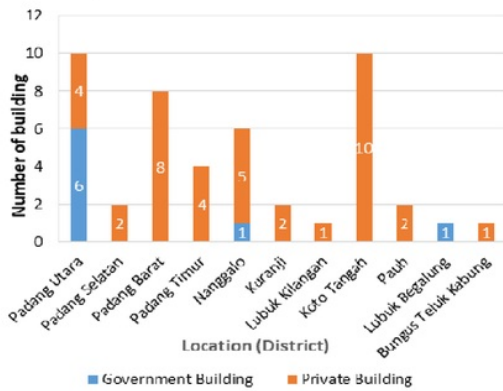
Fig. 3 Number of investigated buildings in each district

This study investigated 47 buildings which consist of 8 government buildings and 39 private buildings. A number of the investigated buildings at every district in Padang city is shown in Fig. 3.

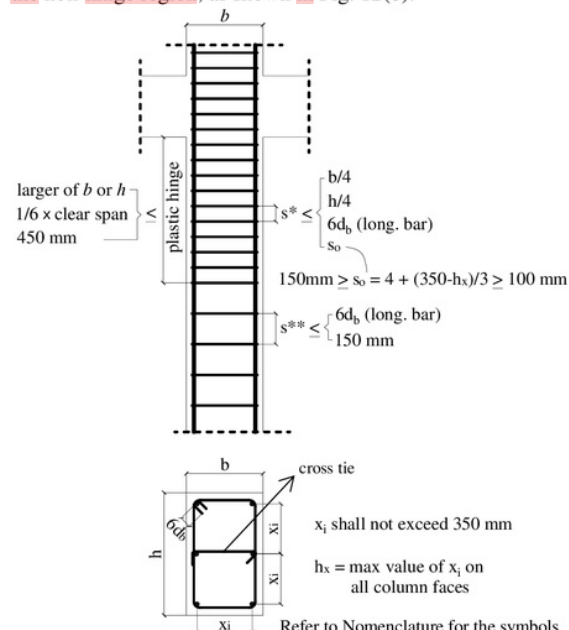
Fig. 11 Requirements for transverse reinforcement of column

Fig. 11 describes the requirements for the maximum spacing of transverse reinforcement in accordance with the Indonesian code [3]. The investigation results in Fig. 12(a) show that twenty eight private buildings (72%) and two government buildings (25%) did not meet the requirement for the spacing of transverse reinforcement in the hinge region. Moreover, thirty five private buildings (90%) and four government buildings (1%) did not meet the requirement for the spacing of transverse reinforcement in the non-hinge region, as shown in Fig. 12(b).

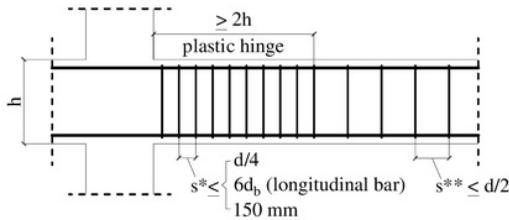
Fig. 17 Requirements for spacing of transverse reinforcement in the beam

3) *Transverse Reinforcement in Beam:* Requirements for the maximum spacing of transverse reinforcement in the beam in the Indonesian code [3] are described in Fig. 17. The investigation results in Fig. 18(a) shows that twenty five private buildings (64%) and one government building (12%) did not meet the requirement for the spacing of transverse reinforcement in the hinge region. Furthermore, seven private buildings (18%) and one government building (12%) did not meet the requirement for the spacing of transverse reinforcement in the non-hinge region, as shown in Fig. 18(b).
