**ICOMSOR - 2016** Book of Extended Abstract

# Lesson Learnt from Padang Earthquake 2009: The Liquefaction effects to Collapsed Buildings

annexes : Damaged building figures due to Padang earthquake in 2009

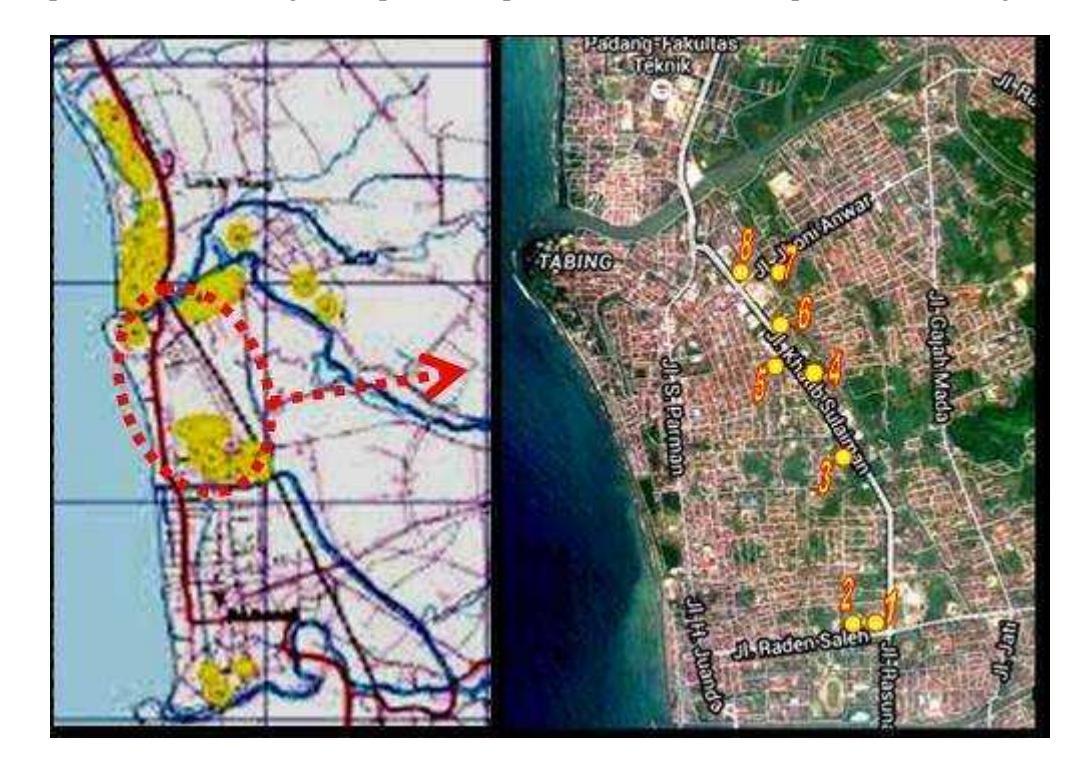
POLTEKES and LIA. While the PU PENGAIRAN building that have been severely damaged by the earthquake in 2007 was grounded by the 2009's earthquake. The locations of those buildings were reported to have the sign of liquefaction phenomena due to earthquake in 2009 (Fig. 2).

Fig 2. Liquefaction in 2009 and locations of buildings. (Building name: 1. BAPPEDA, 2. BKP, 3. SAMSAT, 4. RS SELASIH, 5. SUTAN KASIM, 6. PU PENGAIRAN, 7. POLTEKES and 8. LIA)

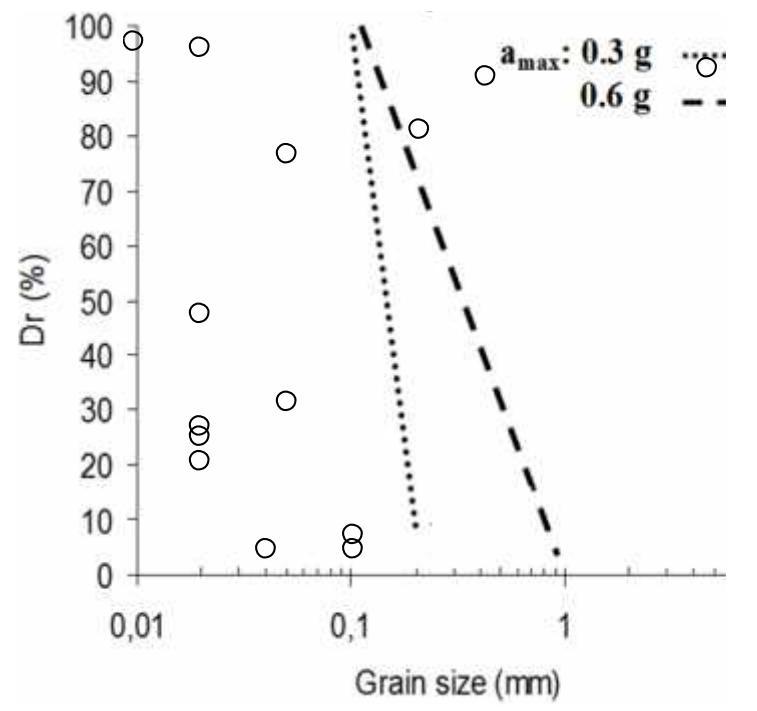
The groundwater table in the site is at a depth of 2 meters. The type of soil layers are dominated by the sediment layer of sandy or silty soils. Based on data from the grain size and relative density, it can be analyzed that the location has liquefaction potential layers (Figure 3).

Depth (m)	N <sub>spt</sub>	D <sub>r</sub> (%)	D <sub>50</sub> (mm)	Soil Class.
2	4	4	0.04	MS
4	39	78	0.05	MS
6	42	83	0.20	SM
8	49	93	0.40	SM
10	4	4	0.10	SM
12	5	7	0.10	SM
14	9	21	0.02	MS
16	11	25	0.02	MS
18	12	27	0.02	MS
20	22	48	0.02	MS
22	14	32	0.05	SM
24	50	94	4.00	SG
26	54	99	0.01	MS
28	53	98	0.02	MS
30	56	102	0.02	MS
N <sub>ave.</sub> =	28	arit.		
N <sub>ave.</sub> =	12	SNI

Fig 3. Liquefaction potential based on grain size and relative density.

Following the 2009 earthquake, a number of seismic and liquefaction studies have been conducted in the Padang city. Geotechnical explorations were done by core drilling at the sites, as well as the test of sampling in the field and laboratory. A particular data of geotechnical drilling as well as field and laboratory tests from BAPPEDA Building location is shown in Table 1. Based on the average standard penetration resistance in the old regulations, the BAPPEDA location were classified to a soft soil site.

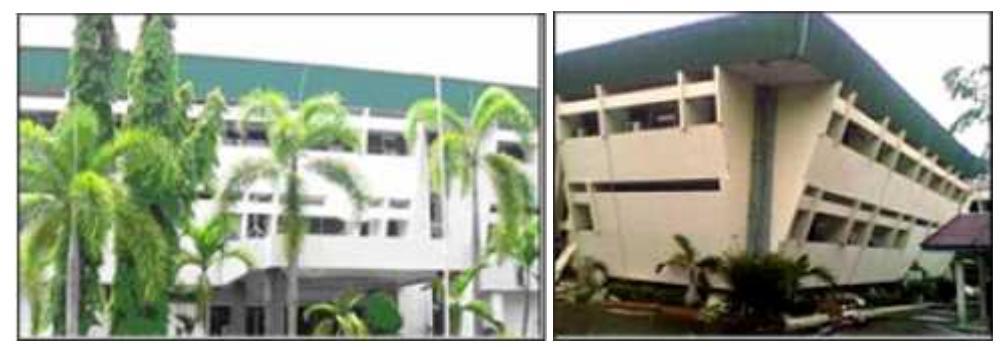
**Fig a1**. BAPPEDA (1975)

BAPPEDA Building that was made in 1975s, can be classified as a very old construction. The building was built without any earthquake resistant building regulations in Indonesia. When the 2007 earthquake happened, the building is reported to suffered from liquefaction and there are cracks in the basement which indicated by boiled sand and leakages. The foundation of the building is made of shallow rounded caissons. This shape of the building also did not give an idea about an earthquake-safe building. This building has a greater mass on the upper level compared to the lower level. In addition the first level do not have wings to withstand shear forces such as the above levels. The first level is the most weak structure of the building. The building is collapsed due to the first level failed withstand earthquake shocks (soft first storey building ).

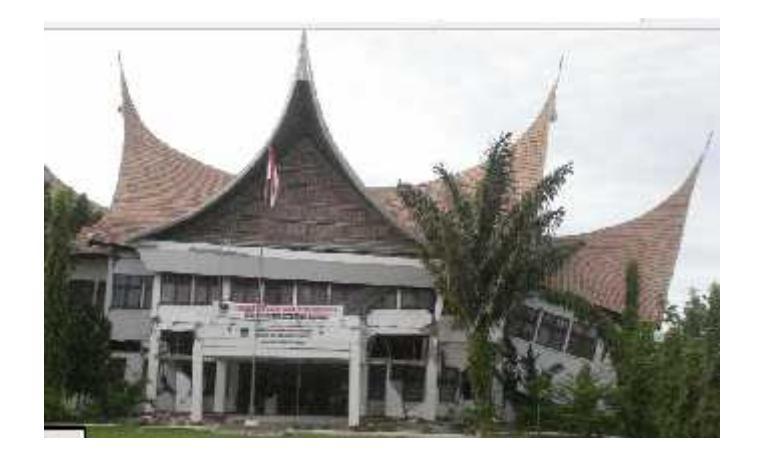
**Fig a2**. BKP (1980)

BKP building located adjacent with BAPPEDA building. This building consists of two floors only. The area of the second floor area wider than the ground floor so that the mass of the upper floor is greater than the lower one. This building also collapsed due to the first floor columns can not withstand during the earthquake. Similarly, the SAMSAT building that consists of only three floors but has a relatively wider on the second and third level. The SAMSAT building also showed the soft first storey building phenomenon. Even thought the structural configuration of those building is relatively simple but on the upper levels there is a mezzanine. This configuration shift up the stiffness and mass center of the building to the upper level.

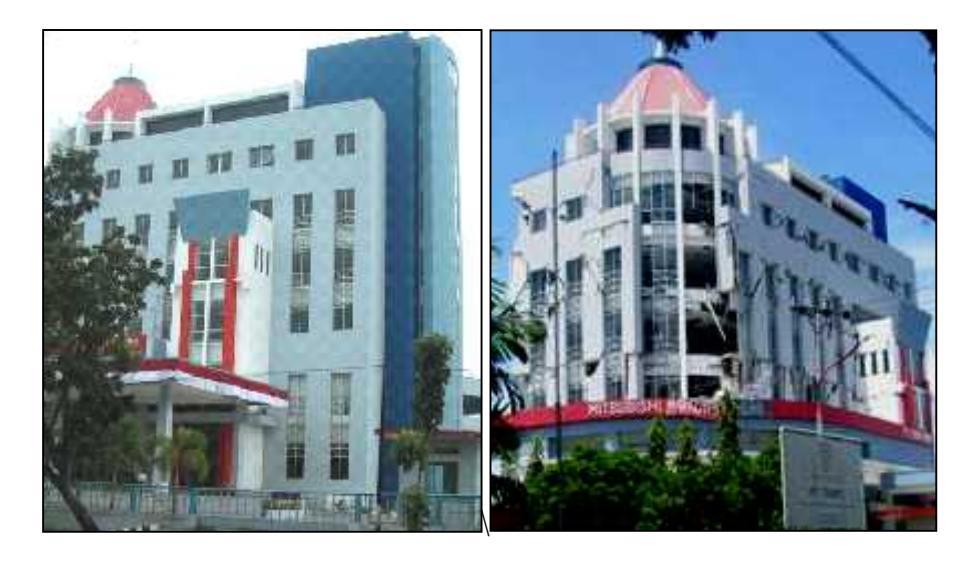
Fig a4. SUTAN KASIM (2007)

SUTAN KASIM building consists of six floors. It was made in the earlier of year 2007. This private owned building was relatively new and has not been used when the earthquake occurred. The building is badly damaged on the walls and slightly on structural elements. The building part that was suffered from severe damage is the between the second floor and the upper floors. The area lower floor is almost twice the upper one. This differences in geometry creates the sudden stiffness change between the second and the third floors.

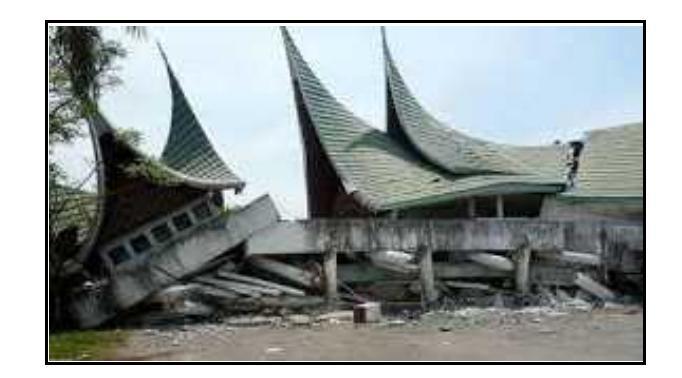
Fig a5. PU PENGAIRAN (1992)

nearly all around the building. This building is structurally also was not safe for occupation and should be demolished. The other adjacent building that was also eliminated is the two floor PU PENGAIRAN Office building. This building promptly has been severely damaged by an Bengkulu earthquake in 2007 and was not used anymore. During the earthquake in 2009 the building was total collapsed.

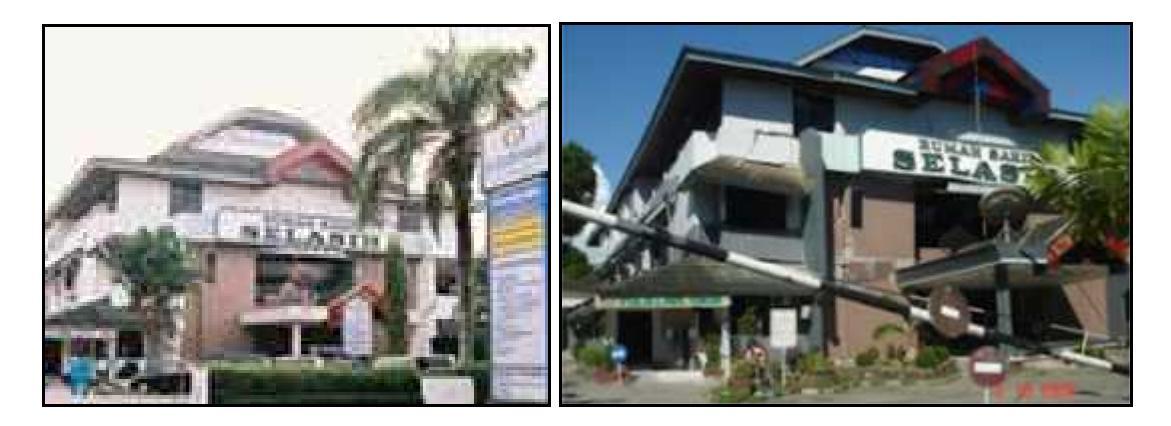
Fig a6. RS SELASIH (1989)

RS SELASIH building was built in the early 1990s, with the foundation of 4m depth rounded caisson. Due to the 2009 earthquake, this building has suffered from differential settlement in
